# Use of Tile Drainage in Massachusetts Cranberry Production

## Use of Tile Drainage in Massachusetts Cranberry Production

This fact sheet is a summation of knowledge gained during research and outreach from 2012 through 2016. The work was undertaken with USDA funding through the Northeast Region SARE (Sustainable Agriculture Research and Education) Program, Project LNE 12-316.

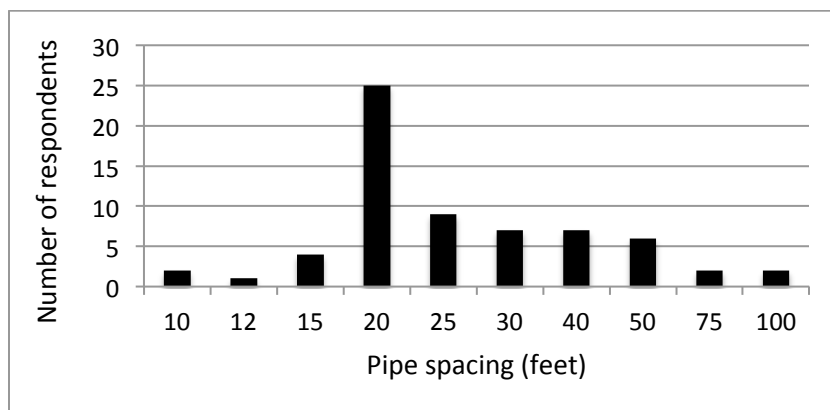
The consensus of the advisory group was that 20 feet is the best spacing. The use of this spacing as an industry-wide preference was confirmed by the results of our initial 2012 survey (shown) and subsequent grower surveys.

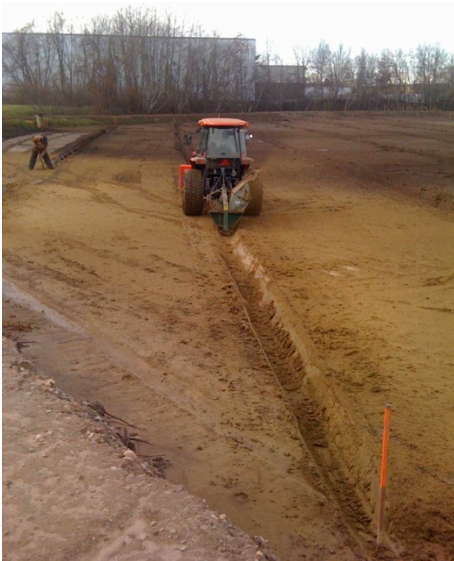
Trenching in a keyhole for tile in a renovation.

Since there was less certainty regarding the correct depth for tile placement, we designed a replicated depth experiment on a bed being renovated to 'Stevens'. The pictures above show the installation of tile drains in keyholes at two depths - 8 and 12 inches from the surface to the bottom of the tile. All drains were spaced at 20 feet with 3 tiles of the 8-inch depth alternating with 3 tiles of the 12-inch depth, so that there were 6 groups for each depth. This installation was done so that we could study response of the plants over the tiles at those depths as well as monitor the impact of tile depth on soil moisture. In the first crop year (2014), yield and fruit quality was better in the areas of the bed with

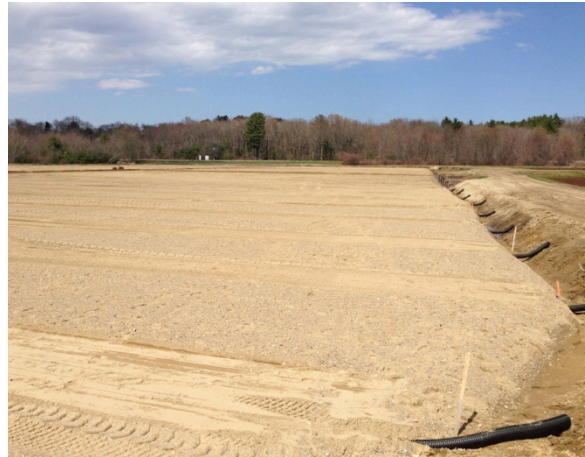
Finished grade showing tiles extending out of keyholes.

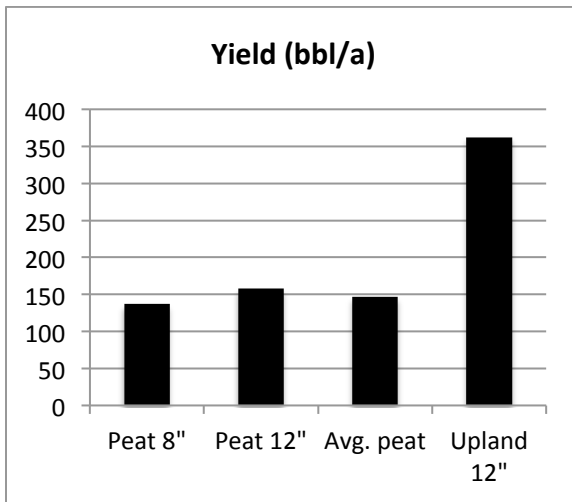
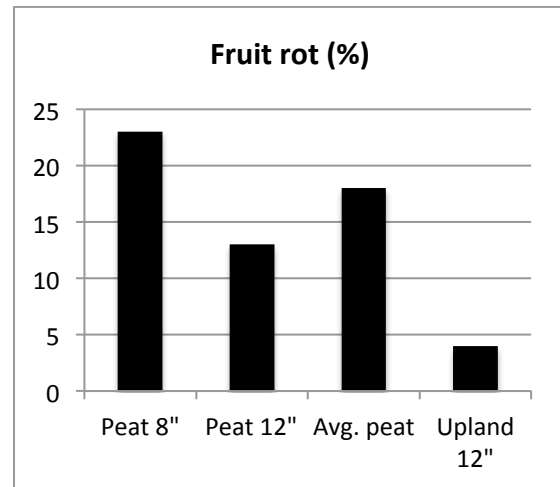
the deeper tiles and those areas had more negative soil tensions (they were drier). However, the following year (data below), there was no difference in yield or soil tension between the two tile depths, while rot remained greater in the area with the shallower tiles. At this same site, there was an upland bog with 12-inch tile depth, renovated to 'Stevens' two years prior to the wetland bed renovation. In 2015, yield and fruit quality on this bed was substantially better than that on either treatment in the other bed.

The upland bed also had much drier soil (more negative average tension over a four-week period in late summer).

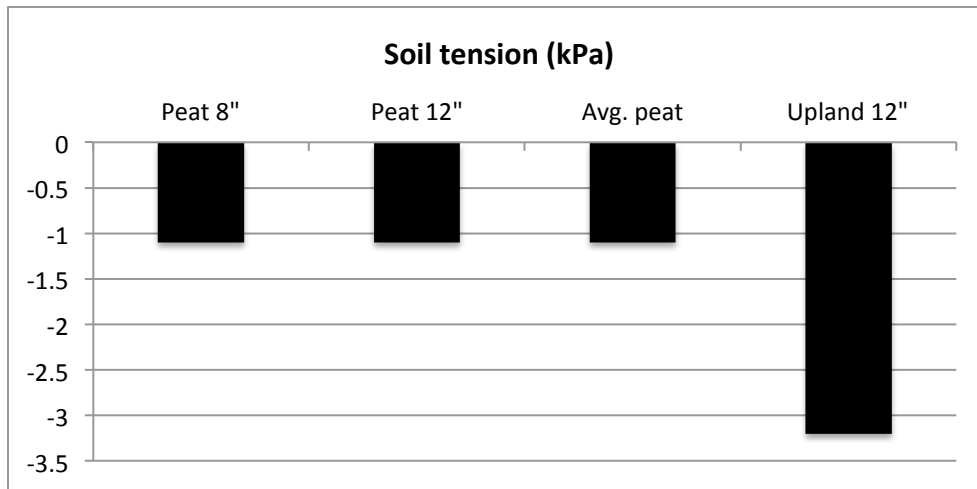
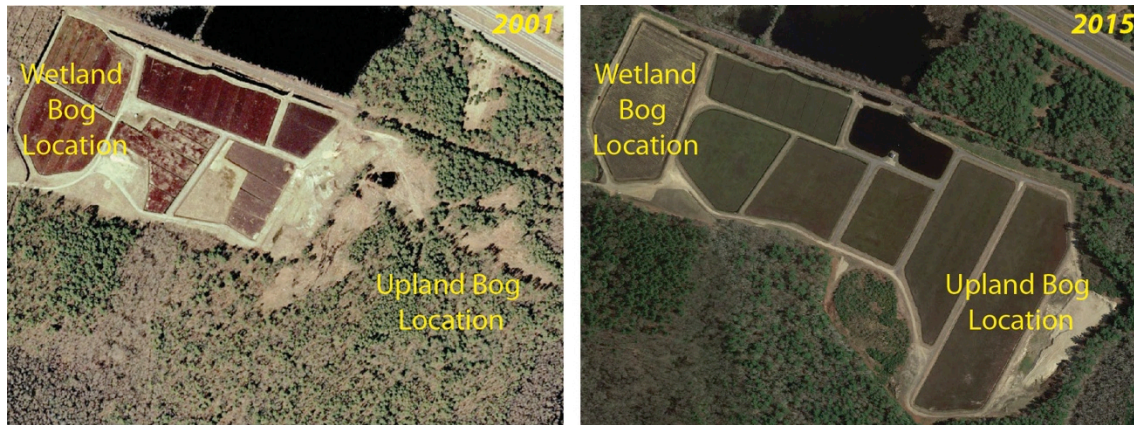
The two beds being compared were at opposite ends of the bog system.

Based on NRCS soil maps, we assumed that the study bed, with tiles placed at differential depths (marked at Wetland Bog in the aerial views), was underlain by peat and that this peat layer was responsible for the wetter conditions compared to the Upland Bog at the other end of the system. However, when we tried to confirm the differences in subgrade using ground penetrating radar, we found that while a small area of the wetland bog was underlain by peat, most of that bed, as well as the upland bog, were underlain by a layer of glacial lake depositional material, a silty layer. Since the two beds have similar subgrade materials and since the entire system is irrigated as one, why is the 'wetland' bog wetter than the upland bog?

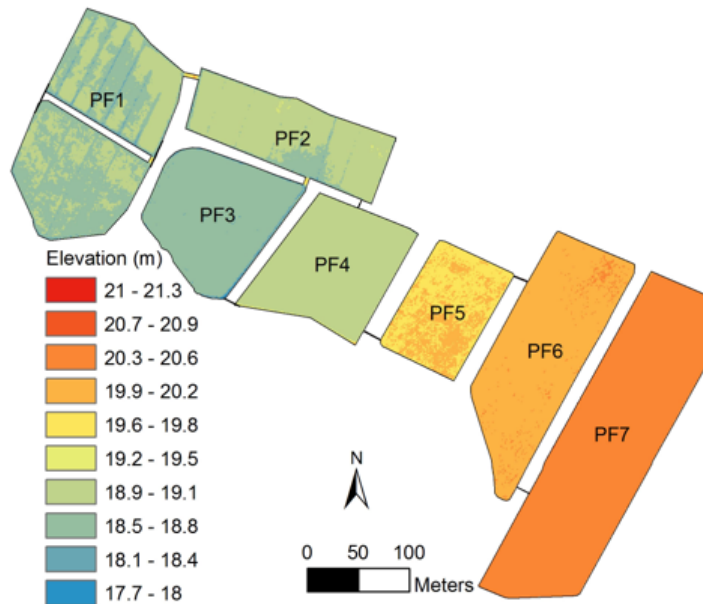
Surface elevation relative to sea level at the study site. PF1 (Wetland Bog) is the bed with differential tile depth, PF7 (Upland Bog) is the comparison, upland bed.

Differences in surface elevation may provide the explanation. The elevation of the upland bed is higher than that of the wetland bed so water drains towards the wetland bed, which is also closer to the water table. So adding the same amount of irrigation to the two beds will result in a wetter soil in PF1, as we saw in this study. Depending on the year and environmental conditions, this may overshadow any differences between the

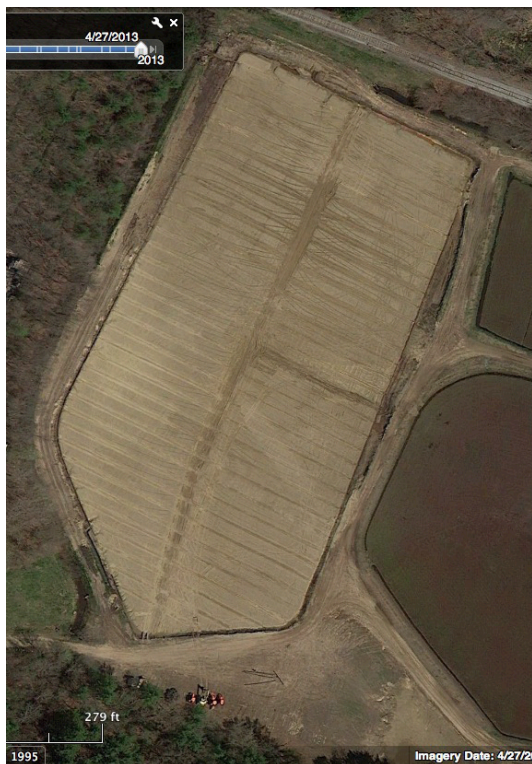
Most growers run tile the long way down a rectangular bed (starting and ending at the short sides). However, design specifics vary. For example, at the site with our depth study, the grower ran tile in from each long end of the bed towards the middle and capped the end closest to the center. There is a space left between the tiles at the center to accommodate the main line for the sprinkler system. The image to the right shows this layout. Whatever layout is selected must be able to accommodate the sprinkler system main and lines.

While the most common horizontal spacing is 20 feet, this may be adjusted based on the width of a specific bed. Since most beds are 'crowned' to facilitate drainage, if the tile depth is uniform in relation to the surface, the drains will slant towards the edge ditches.

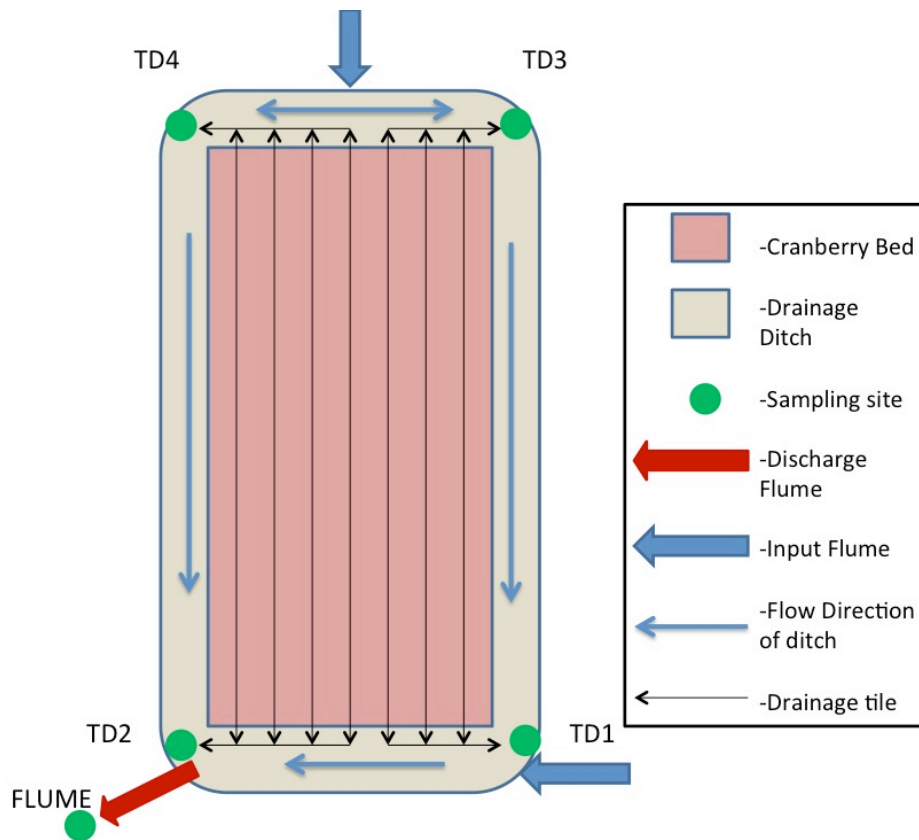
Part of our tile work was a study conducted by Nick Alverson to characterize the function of tiles in a renovated bed. The diagram below shows the study design.

TD1-4 are groups of tiles joined by a pipe. The pipe is used to connect groups of drains that can then be sampled using automated equipment. See the picture below.

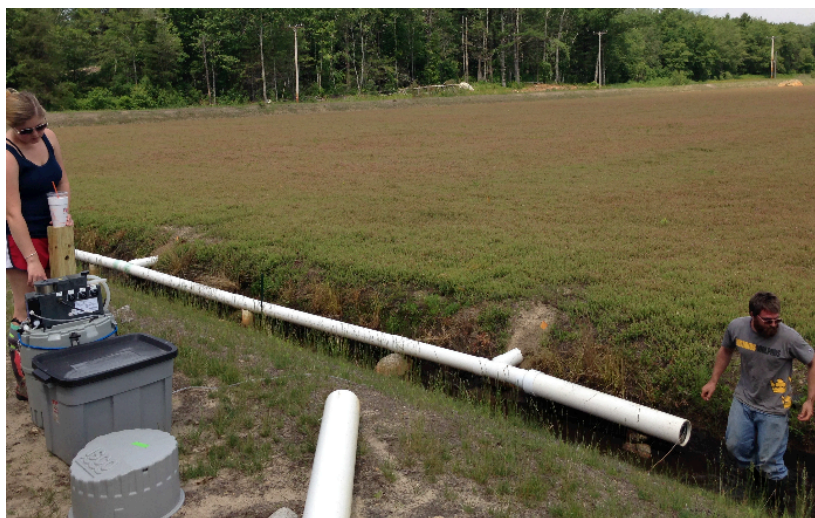
The tiles in this bed were 25 feet apart and about 2 feet deep. For two years, flow data were gathered as were samples to quantify nitrogen in the drainage leaving the tiles.

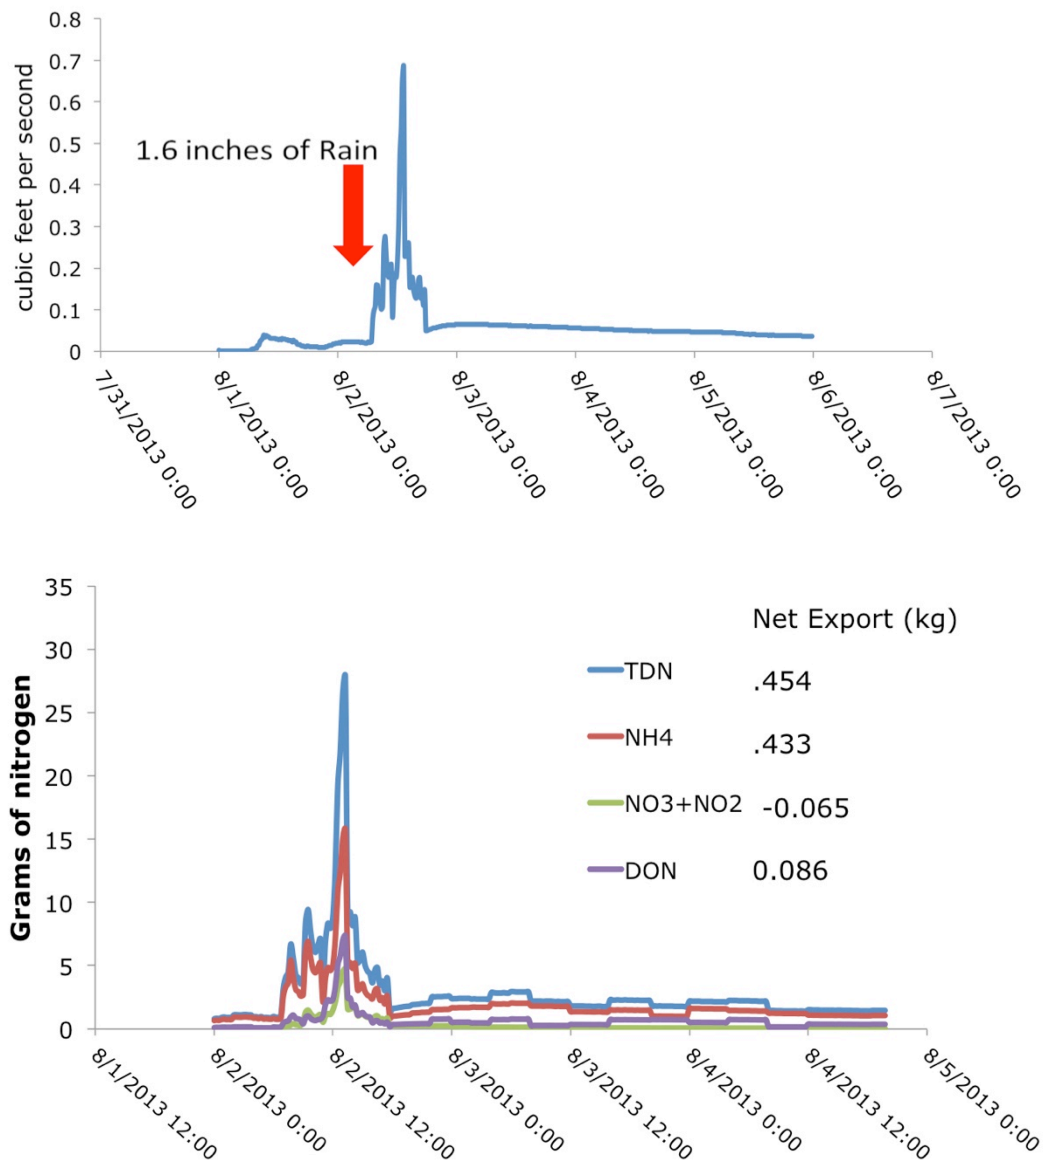
The graphic below shows that water rapidly drained from the bed after a 1.6 inch rain event. However, the tiles also acted to convey nitrogen, particularly ammonium, from the bed following this large rain event. This is likely nitrogen released from applied fertilizer or mineralized organic nitrogen based on the predominance of ammonium in the drainage water.

Water flow from tile drains following a large rain event (top). Nitrogen in tile drainage (bottom).

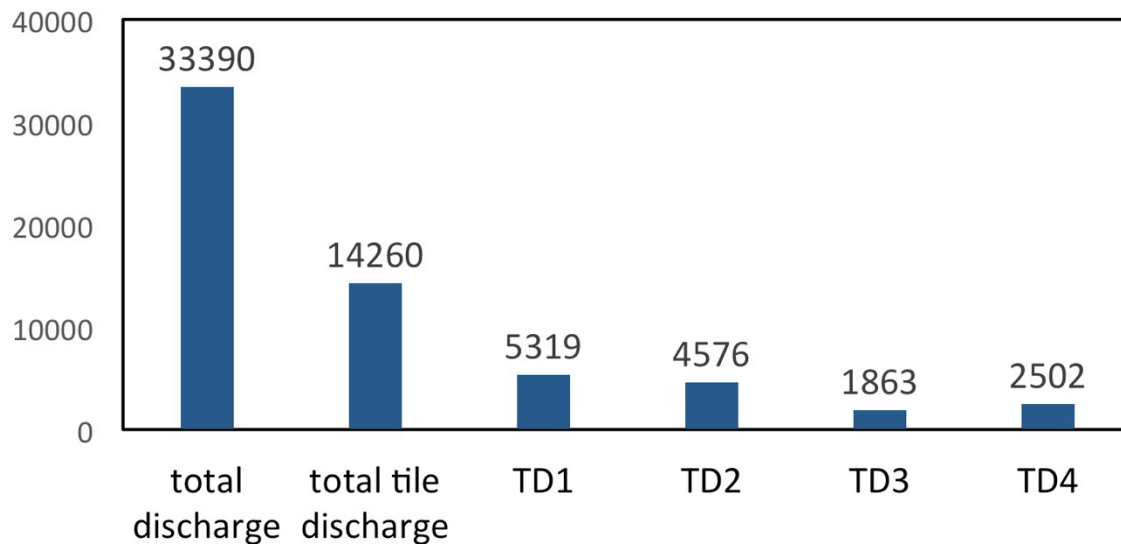
## Total Discharge from Bed vs Discharge from Tiles (cubic meters) 2014

This graph shows the total drainage from this bed in 2014, including flood discharges. About 42% of the total discharge was through the tiles. As one might expect, the groups of tiles at the down-slope end of the bed (TD1 and TD2) discharged more water than those up slope. We then looked at the water and nitrogen budgets for the summer of 2014 (rainfall and irrigation drainage, no floods).

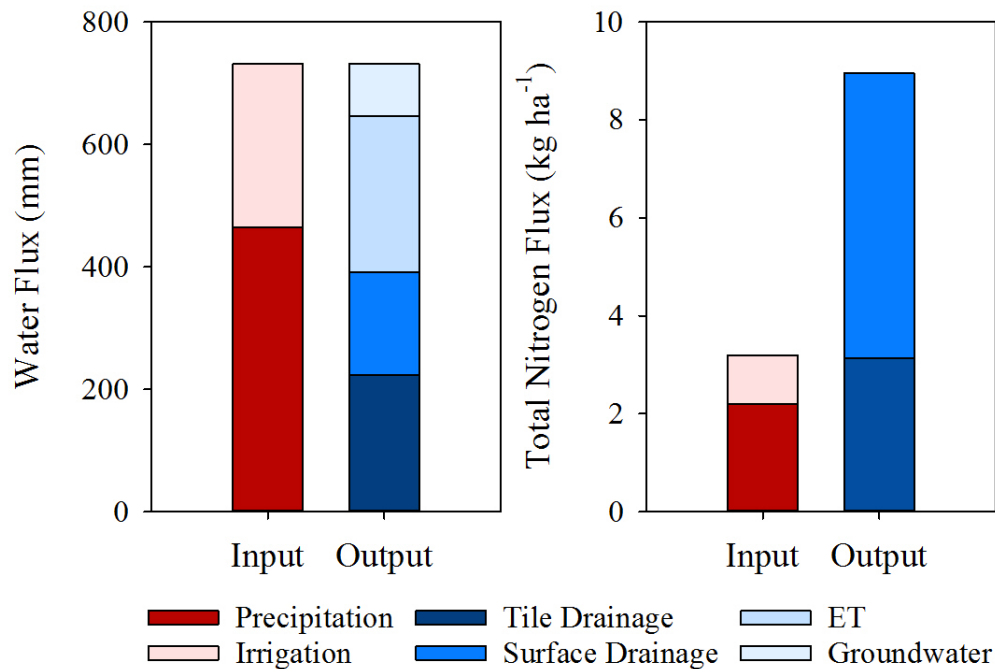
Summer season water and nitrogen budgets for year 2014.

For the summer season of 2014, we found similar patterns in water and nitrogen export by tile drainage, which accounted for about one-third of all water and nitrogen outputs. We calculated that tile drainage removed 169 mm of water and exported 3.1 kg N ha<sup>-1</sup> on a seasonal basis. These values are likely on the high end of the normal range, as summer rainfall in 2014 was 23% higher than the 20-year average for East Wareham, Massachusetts.

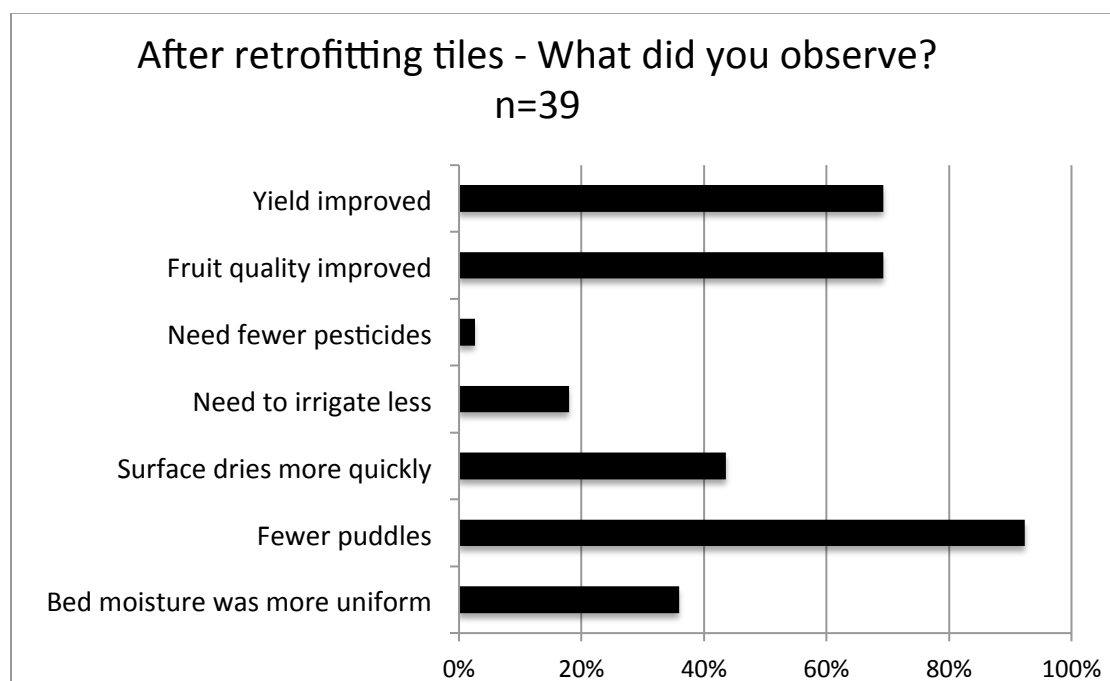
In January 2016, we specifically asked growers about their experiences with drainage tiles that were retro-fitted into existing beds. Of the 57 respondents that used tiles, 39 had retro-fitted tiles into existing beds. In addition to improvements in drainage and soil moisture, 70% reported observing increased yield and reduced fruit rot. This reinforces the case that we have been making for more than 10 years that saturated soils lead to reduced yield and quality.

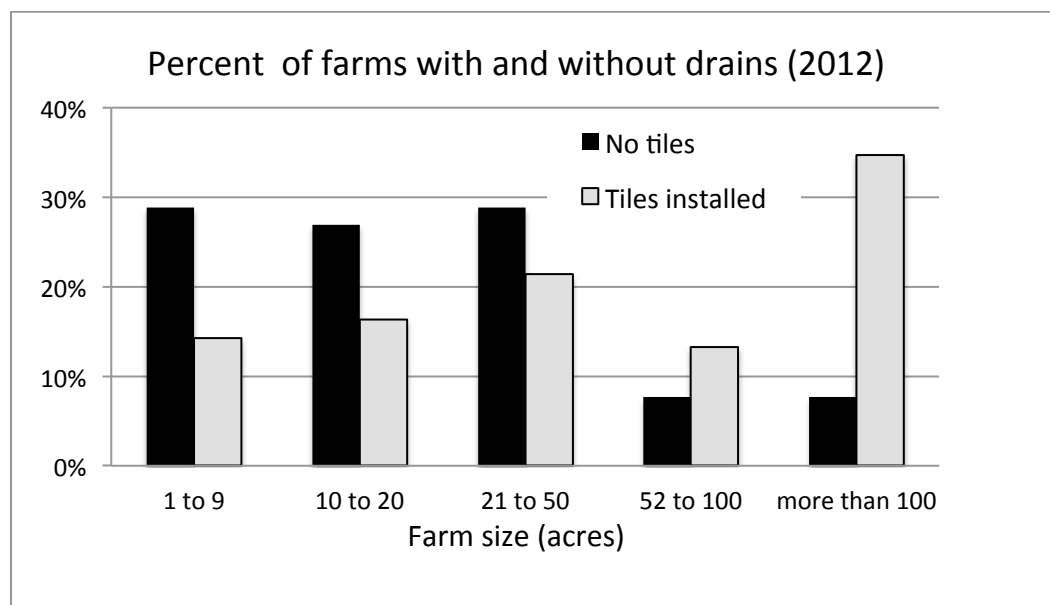
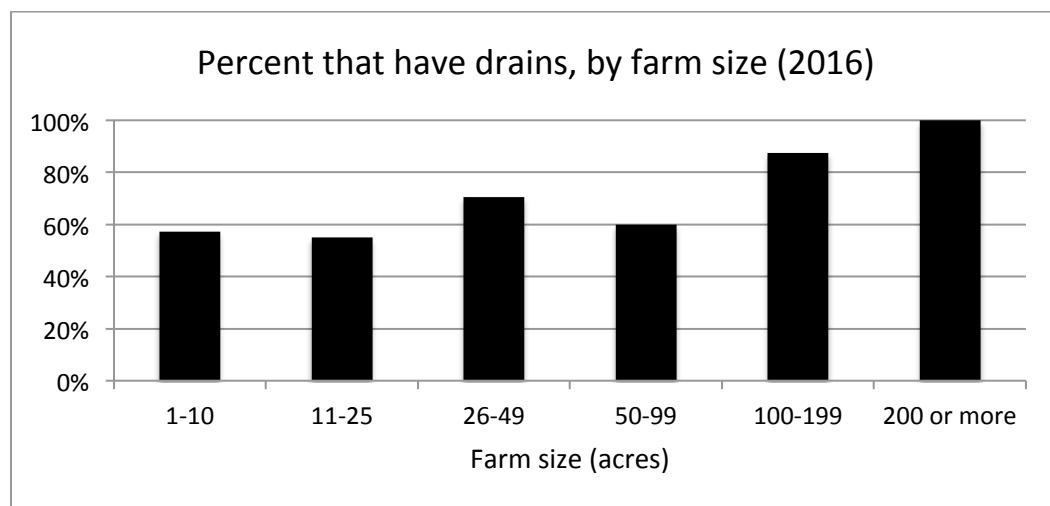
Large acreage growers were more likely to have tiles installed on at least some of their acreage (similar in 2012 and 2016 surveys - see data below). Respondents in the 2012 survey were using tiles on renovations, new plantings, and established beds (retro-fitting tile into the beds). More than 80% responded that they were very likely or likely to include tiles in any renovation.

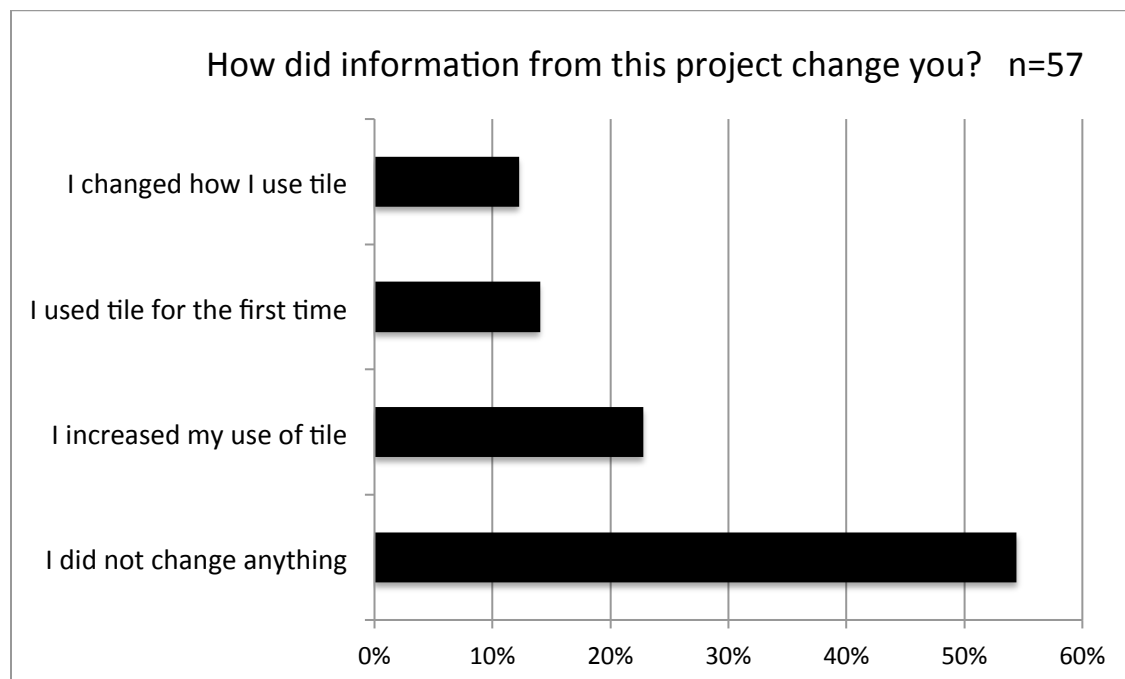
In our final survey, we asked growers how the knowledge from this project had changed their use of tile drainage. While many did not attribute the change in their tile use directly to the work of our research and grower team, there was measurable change: 21 of 57 respondents (37%) that had tile had either used it for the first time or increased their use based on project information.

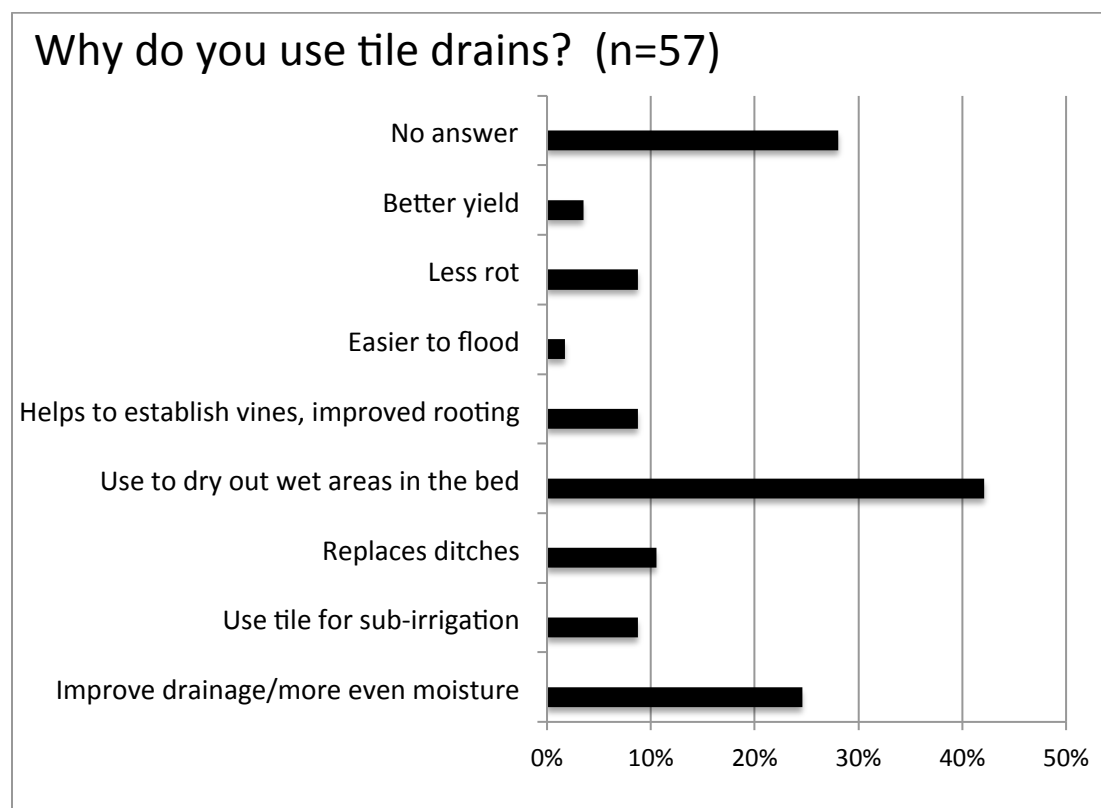
Those 57 growers were also asked why they use tile drainage. As was the case when we started in 2012, drying out beds and evening out soil moisture remained the primary

reasons cited for using tile. While less than 10% cited improved yield or decreased rot as primary motivators, 70% of those that installed tiles reported improvements in both (see previous section).
